Lessons learned the Godafoss accident in Feb. 2011.

Oil spill recovery at -20°C

The Godafoss accident

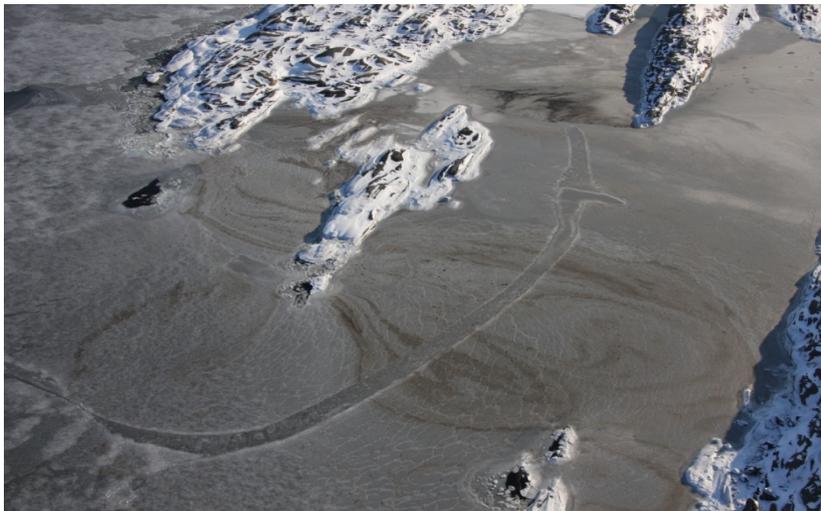
Figure 3 Oil frozen into ice in the Niteroi archipelago.

The oil that froze into the ice (from drifting on ice-free water) was hard to collect. Visually there appeared to be large amounts of oil frozen into the new ice. After collecting it with excavators placed on a barge, the amount of oil collected as

compared to ice was miniscule. With ice thickness up to 25 cm., 1000 sq. meters of oily ice gave only 1 liter of oil after melting. Therefore, following these initial tests, collecting ice was not carried out. Some of the drift ice that had mixed with free floating oil inside the booms was collected. The percentage of oil versus ice/water was then 3-5%.
